### Product Test Report

Product name:	Sauna light strip RGBW	Testers:	Niu Heng	Test date:	Start: 2022.04.20 End: 2022.04.27
Test items:	High temperature and high humidity test	Type of test:	Reliability test	Sample Size:	2M
1. Test equipment: ZH-TH-80D programmable constant temperature and humidity test chamber					
2. Test condition: the instrument is programmed to set the temperature at 85 °C and humidity at 85% .Cycle Testing 168 hours.					
3. Test requirements: light strip natural spread open into the equipment lighting test					
4. Test record:					
<b>Before testing</b>

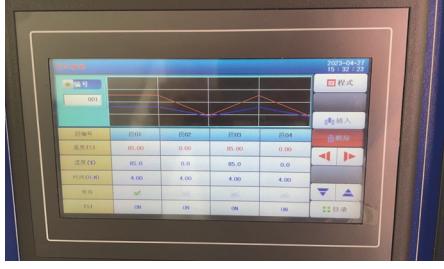
<b>Test parameter setting</b>

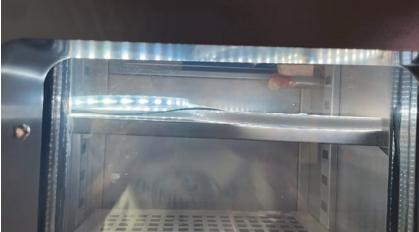
<b>Testing</b>

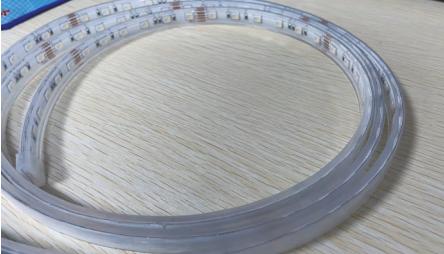
<b>Test complete</b>

5. Test results: there were no defects before and after the test:

6. Conclusion: After 168 hours of high temperature and humidity testing, the light strip showed no electrical defects, with a luminous flux decay of less than 3%. The high temperature and humidity test was passed.
